The Uniform Building Inspection Report™ Condensed

Single Family Residence:
, Scottsdale, AZ

Inspection Date:
9/19/2005, 1:00:00 AM

Inspection Company:
Checklist Inspections
835 W Warner Rd. Suite 101-465,
Gilbert, AZ 85233
(480)-361-8120

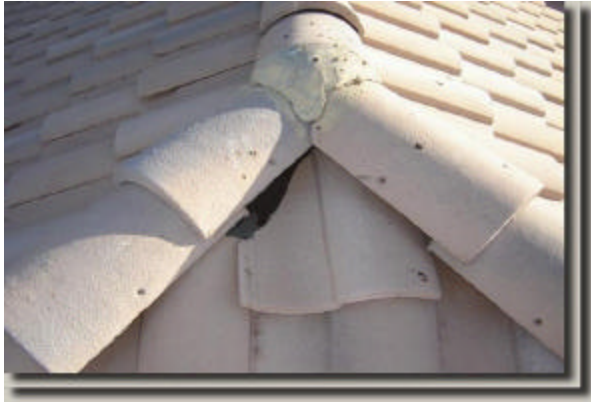
Photo: 1080.03 (1)

[R] 1080.03: Roof tiles out of position.
Several of the roof tiles at the hip ridges are out of position, and need to be set back and secured. This was noted over garage.
See series 1080.03 photo(s)

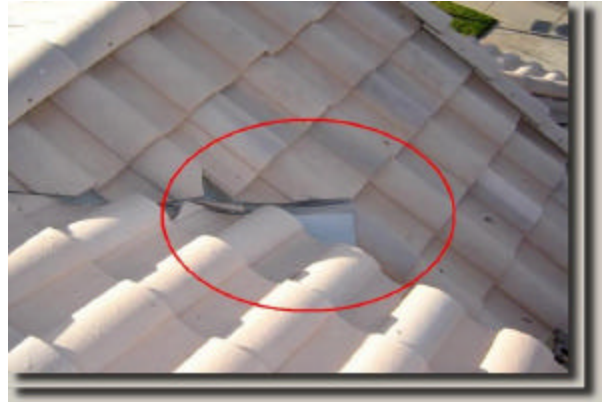
Photo: 1230.04 (1)

[R] 1230.04: Metal flashing faulty or otherwise amiss.
The metal flashing is allowing water to run under tiles. Recommend repair/replace flashing. This was noted at the West elevation over master bedroom.
See also the interior section of report.
See series 1230.04 photo(s)

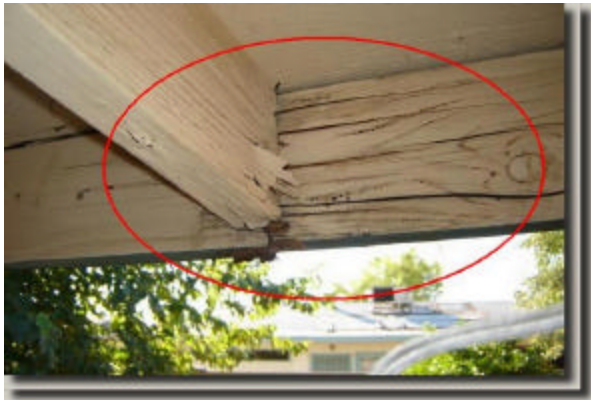
Photo: 1450.01 (1)

[R] 1450.01: Fascia damaged.
The fascia board is rotted, and should be replaced to prevent the rot from spreading further or into the truss tails. This condition exist across the East elevation.
See series 1450.01 photo(s)

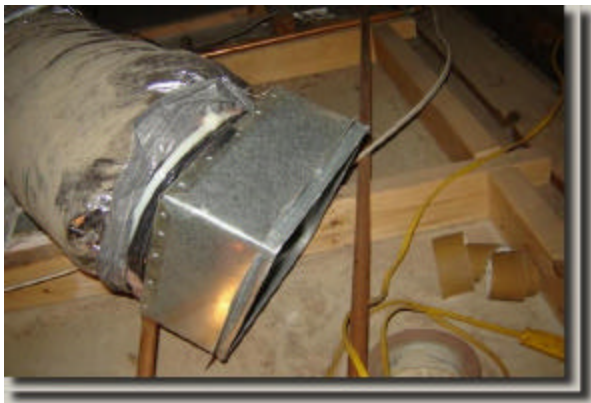
Photo: 2200.02 (1)

[R] 2200.02: Ducting separated.
An unused air duct register ducting is in the attic blowing conditioned air. Recommend removing unused duct work.
See series 2200.02 photo(s)

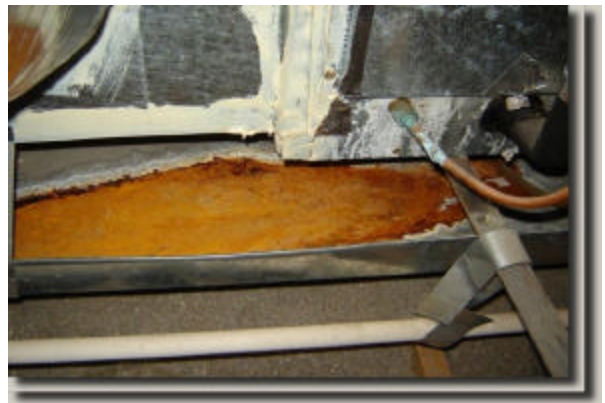
Photo: 2310.05 (1)

[R] [R] 2310.05: Condensate drain faulty or otherwise amiss.
The condensate pan in the attic is filled with rust stains. Recommend to have unit reviewed by a licensed HVAC technician to determine cause.
See series 2310.05 photo(s)

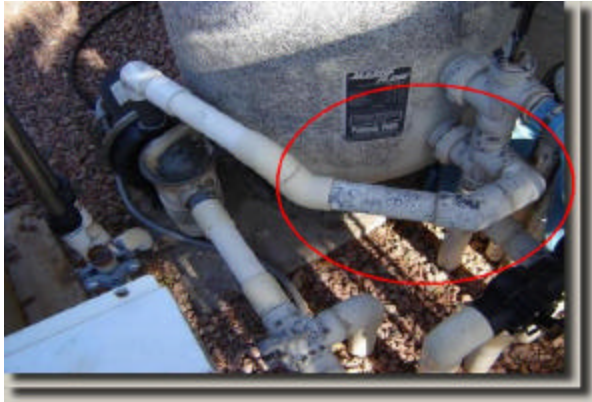
Photo: 3570.01 (1)

[R] 3570.01: Pipe or fitting leak(s).
There is a current leak where the piping meets the pool filter.
Recommend repair.
See series 3570.01 photo(s)

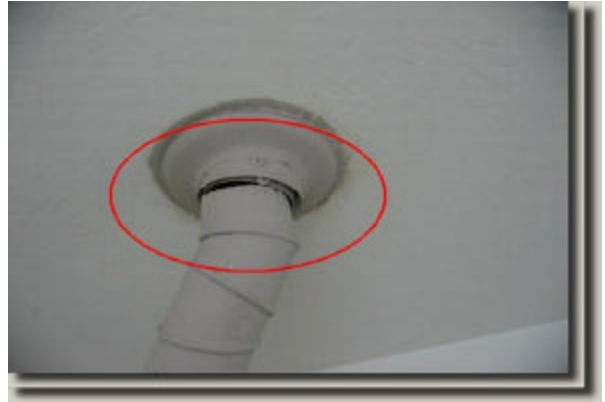
Photo: 4080.01 (1)

[R] 4080.01: Water heater vent improper.
The "B" vent is disconnected at the ceiling and is currently a safety hazard. Should be reconnected and screwed together.
See series 4080.01 photo(s)

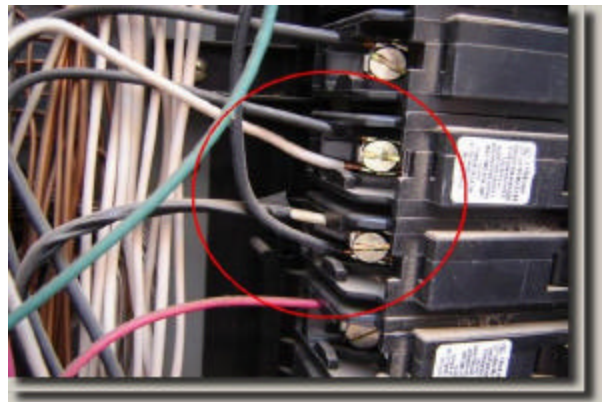
Photo: 5230 (1)

[R] 5230: Double wires on breaker or fuse.
There are two double taps. Circuit breakers should be added by a licensed electrician as necessary.
See series 5230 photo(s)

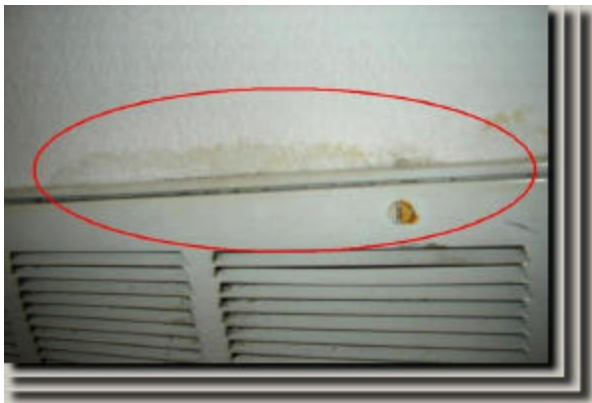
Photo: 7000.01 (1)

[R] 7000.01: Stain noted on interior surface.
Noted at HVAC return. This is caused by condensate overflow.
Recommend to have the HVAC unit reviewed and repaired by a licensed HVAC technician.
See series 7000.01 photo(s)

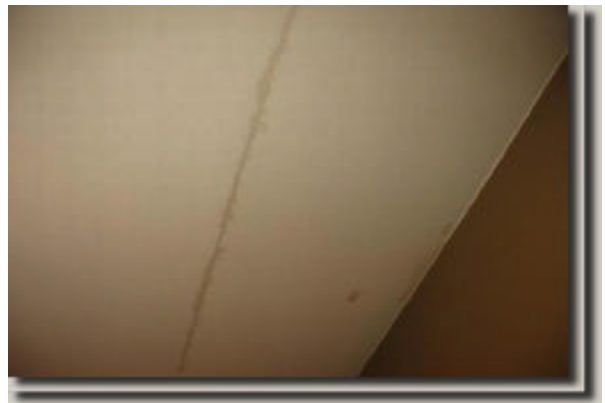
Photo: 7010 (1)

[R] 7010: Water intrusion evidence or water damage noted.
Stain from water leakage at roof noted in master bedroom.
Recommend repair by a licensed roofing contractor.
See also roofing section of report.
See series 7010 photo(s)

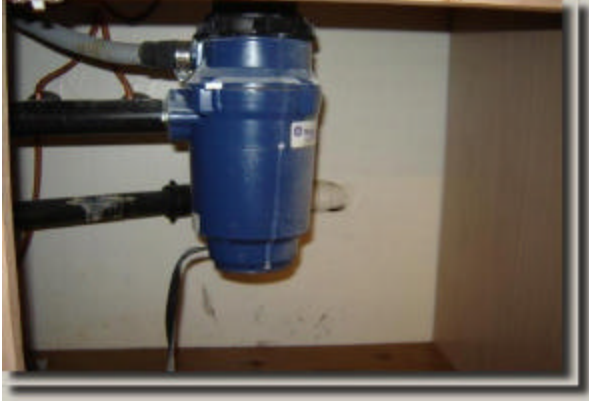
Photo: 8410.04 (1)

[R] 8410.04: Disposal damaged.
Disposal is cracked, and leaking when turned on. Recommend replacement.
See series 8410.04 photo(s)

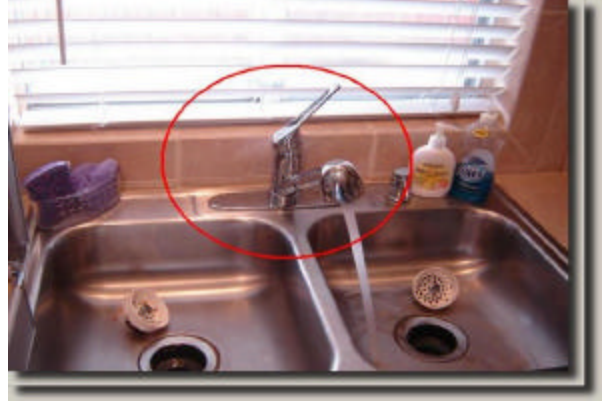
Photo: 8660.01 (1)

[R] 8660.01: Sink faucet leaks at stem.
The kitchen faucet leaks and works poorly. Recommend replacement.
See series 8660.01 photo(s)

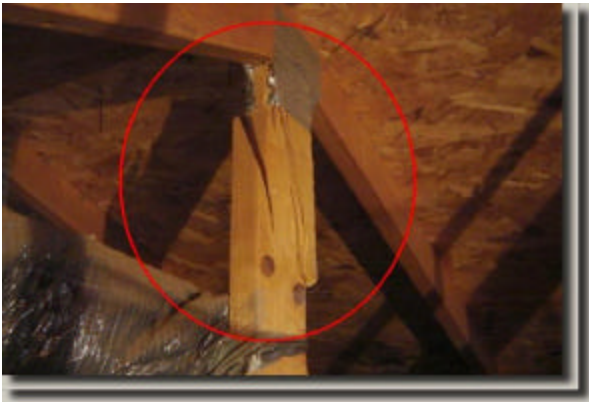
Photo: 9200.02 (1)

[R] 9200.02: Framing member cracked.
One section of a truss is cracked and should be repaired. Should have the affected area repaired and certified by a licensed structural engineer. This condition exists at the 8th truss to the west of the attic entry.
See series 9200.02 photo(s)

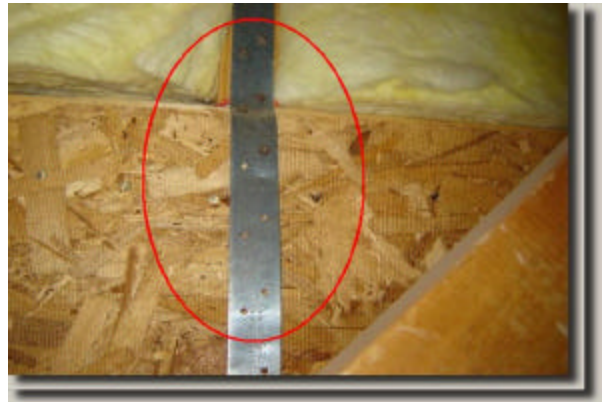
Photo: 9240 (1)

[R] 9240: Questionable framing techniques and workmanship.
All strapping is required to have a nail in all holes provided. All strapping in the single car garage attic was missing nails.
See series 9240 photo(s)

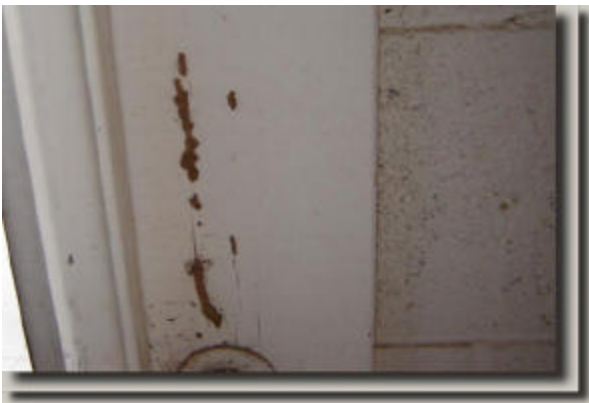
Photo: 9850.01 (1)

[R] 9850.01: Wood boring or other insect infestation suspected.
A "Mud" tube was located on the garage door frame, which is indicative of a wood boring insect infestation. Be sure to review your pest inspection report.
See series 9850.01 photo(s)
